## Information regarding the SOLID 60E-2 Flash Fusing Error 1E/1F

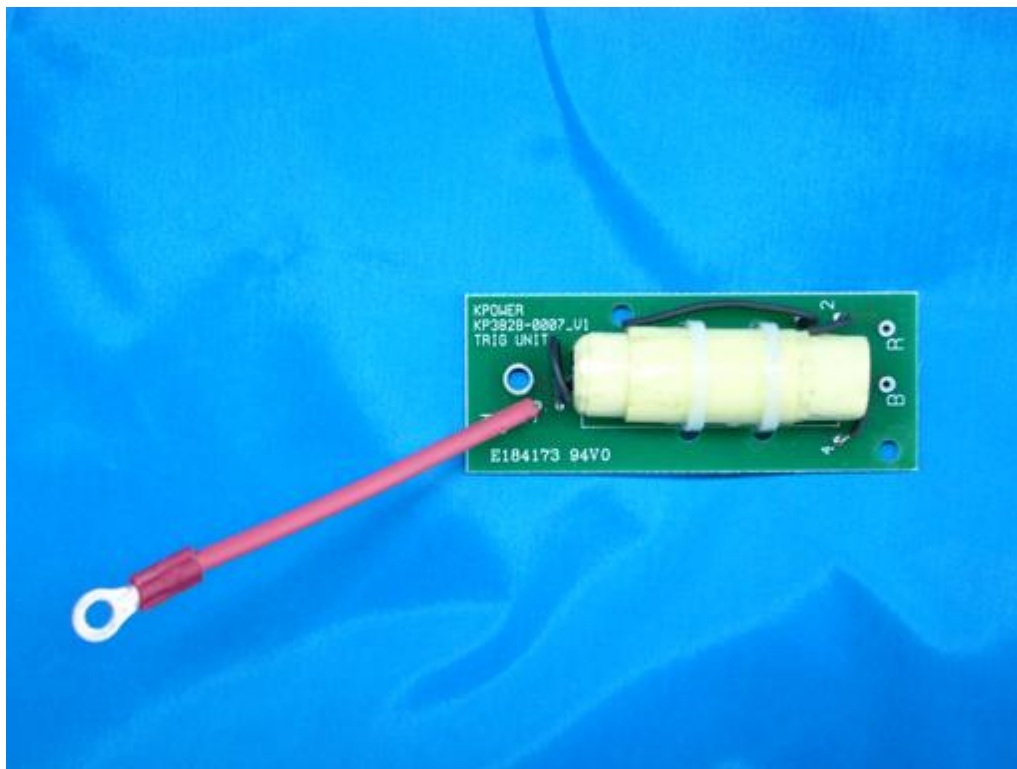
XENON LAMP TRIGGER COIL UNIT <KP03-0312-000-01>

1. *immediately when the printer starts to print.* No flash at all.  
That indicates in most cases a defective flash power supply. But nevertheless all other responsible parts (xenon lamp, cables and connectors, trigger coil) should be checked anyway.
2. *Intermittent, after a random number of pages.* In that case a worn xenon lamp or worn connectors are the most likely reason. But also a worn Trigger coil could be responsible. We recommend to exchange that trigger coil, as a part of preventive maintenance, every 1,8 million pages which means it should be changed together with every second xenon lamp.
