Printronix Technical Bulletin	Number TB-0006	Revision A
Subject P5000/IBM™ 6400 Spool Printer End of Support	Product Type P5000	Date 15/06/2016
	Originator Technical Support	Page 1 of 2

Subject: P5000/IBM™ 6400 Spool Printer End of Support – *CRITICAL UPDATE*

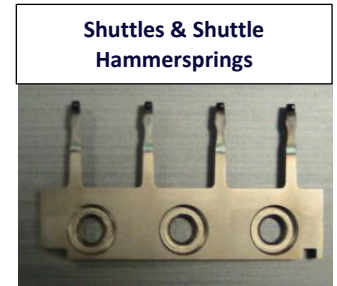
Shuttle Assemblies and related parts

- **Concern:** Hammer Bank Calibration/Hammer Spring (Frets) Tip wear over time.
- **Encountered Problem:** Poor print quality and unreadable barcodes due to improper dot formation. Light and dark areas of print, premature and reduced ribbon life.

Note: Calibrating the retract setting of each hammerspring is a highly precise process. Only the Printronix factory can warrant this process which requires specials tools, jigs, training and calibration equipment. Relying on used, non-factory sources result in problems due to worn carbide tips, improper retract settings, resulting in needless expensive repairs and additional problems.
